POLICE ACADEMY
HILLA, IRAQ

SIGIR PA-05-032
JANUARY 31, 2006

SUBJECT: Report on Project Assessment of the Police Academy, Hilla, Iraq
(Report Number SIGIR-PA-05-032)

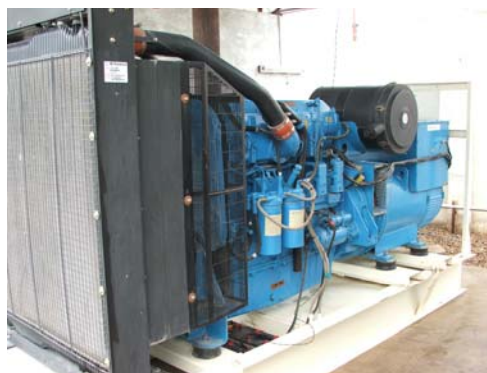
Our onsite inspection showed there are two generators: one rated at 615 kilowatts (Site Photo 1) and the other at 220 kilowatts (Site Photo 2). The police academy relies on commercial power for its primary source of electricity. We could not determine how much of the police academy's electrical demand was met with the two generators because the contract files do not contain any information regarding the existing conditions survey or power supply design.

Site Photo 1. 615 Kilowatt Generator

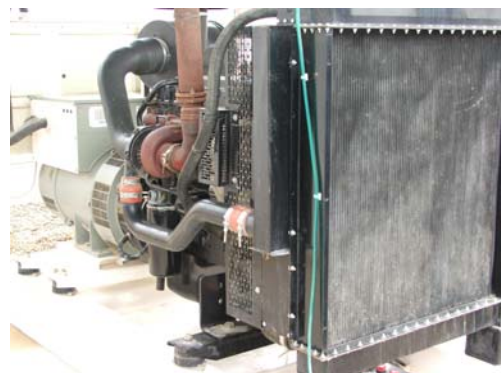
Site Photo 2. 220 KW Generator

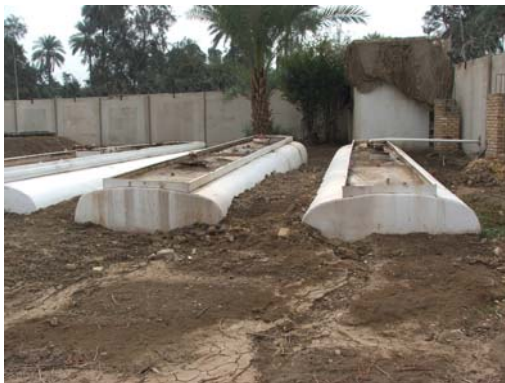
The visible parts of the sanitary sewer system observed during the site visit were the collection tanks. There was one above ground wastewater collection tank and three tanks partially buried (Site Photo 3). In addition, the SBIG representative who accompanied us on the site visit indicated there was also an underground wastewater collection tank (Site Photo 7). We could not determine whether there was enough capacity in these tanks to meet the daily demands of the Academy students and staff without a design illustrating the complete system.

Site Photo 3. Partially Buried Wastewater Tank

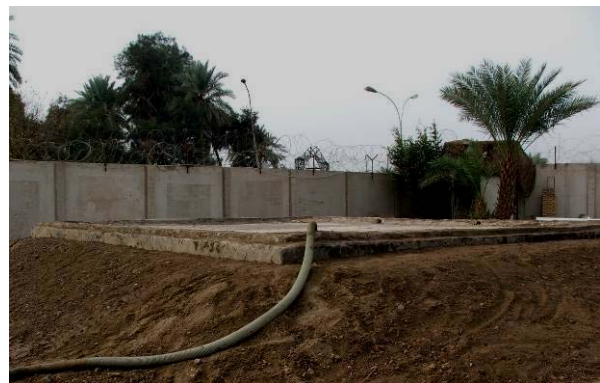
Site Photo 4. Underground Wastewater Tank

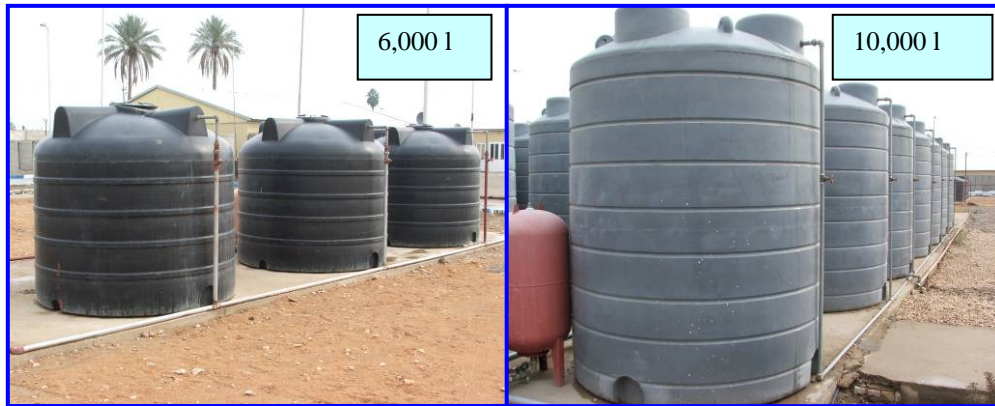
During our site visit, we observed two sets of water storage tanks, one set of three tanks, approximately 6,000 liters each and the other set comprised of 21 tanks, 10,000 liters each (Site Photo 5). In addition, the site contained a reverse osmosis water purification system. We were unable to determine if the entire system met the water demands for the police academy. We could not verify if the system was properly constructed and integrated without a design or manufacturers' catalog cut information providing details on the system and major components.

Site Photo 5. Water Storage Tanks

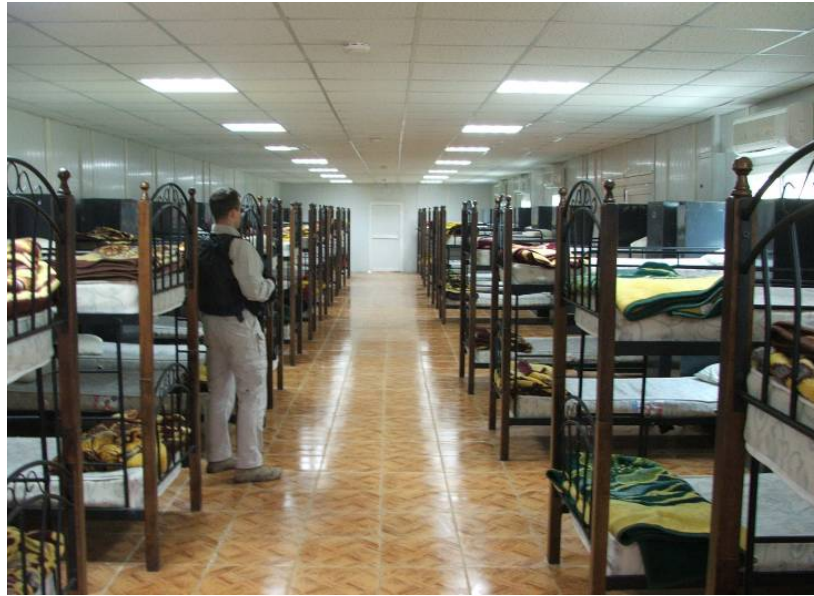
Due to time constraints, we visited only one student barracks during our onsite assessment. As shown in Site Photo 6, the student billeting consists of one large open room with bunk beds and lockers.

Site Photo 6. Student Billeting at the Hilla Police Academy

The barracks appeared to be in serviceable condition. In the 22 May 2005 Cure Notice issued by the Contracting Officer, one of the items included “inadequate air conditioning for student billeting.” The buildings containing student billeting contained six, split system air conditioning units for heating and cooling. Section 5.15.5 of the SOW required submittals on air conditioning systems, heaters, and fans. We found no submittals on the air conditioning system in our review of the contract file. Thus, we could not determine if the six units sufficiently met the cooling demand.

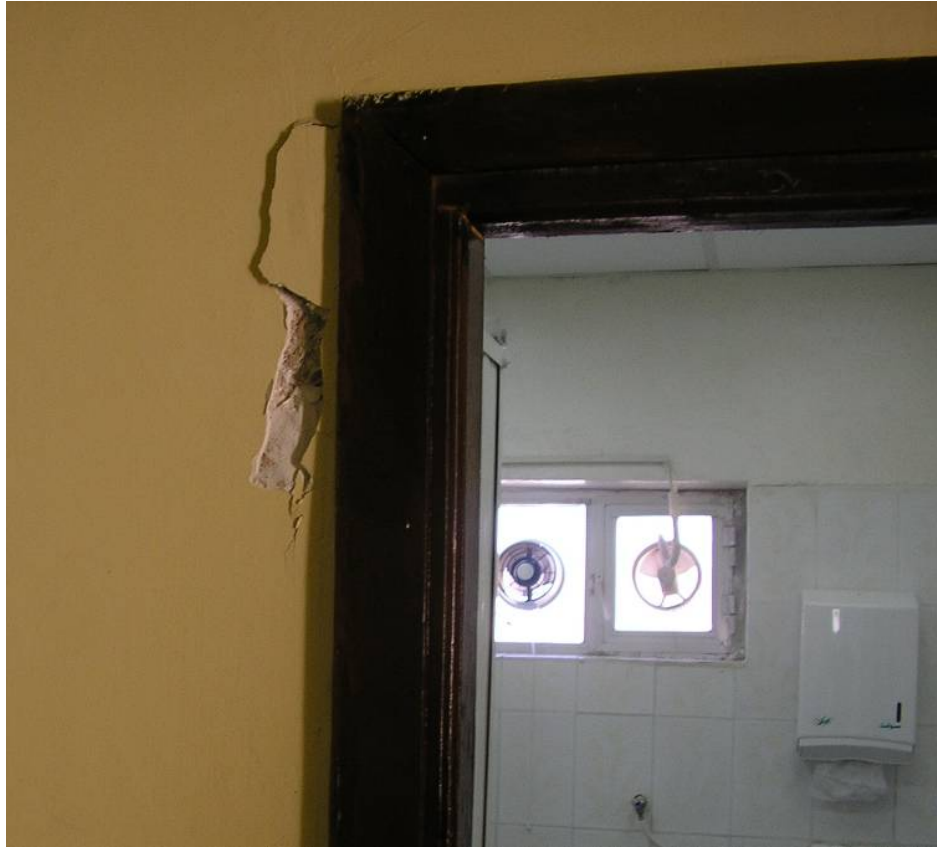
There were settlement cracks in the walls (Site Photo 7) at several locations within the building. We also noticed moisture damage along the hallway walls outside the bathrooms (Site Photo 8). The Contracting Officer in the Cure Notice to SBIG dated 22 May 2005 had noted these discrepancies.

Site Photo 7. Crack in Hallway Wall in Instructor Billeting Area (Photo courtesy of Contracting Officer Representative; taken on 9 December 2005)

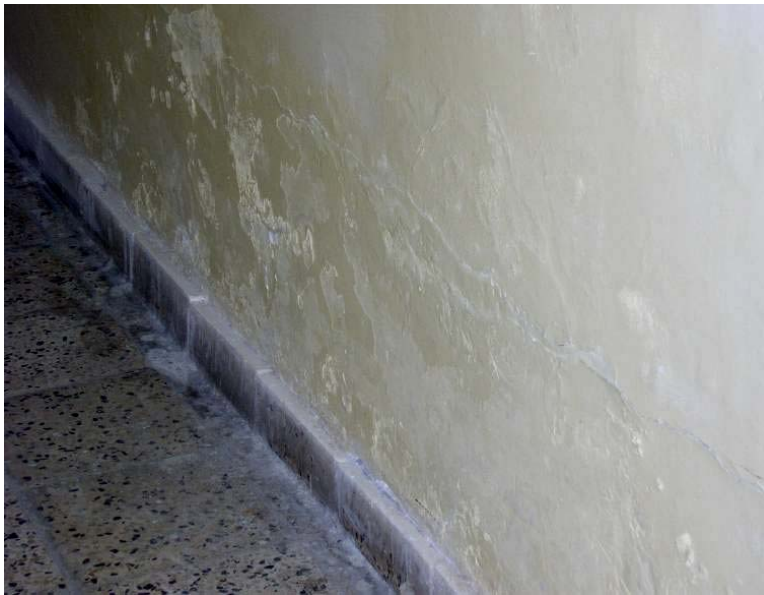
Site Photo 8. Moisture Damage in Wall Adjacent to Bathroom in Instructor Billeting Area

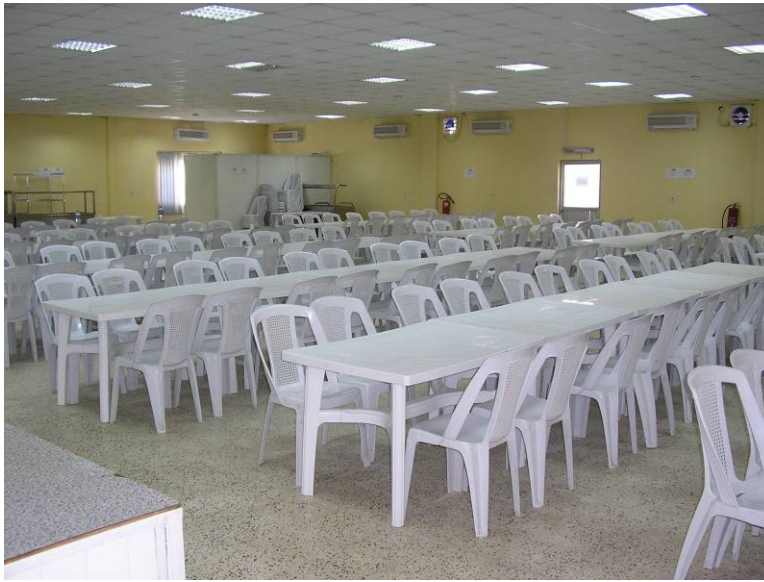
The dining facility appeared to be in generally good condition (Site Photo 9). However, we did find a crack in one of the exterior walls near an exhaust fan in the dining area. Also, in one corner of the dining area, there was a water stain and mold along the wall running down from the ceiling tile.

Site Photo 9. The Dining Facility

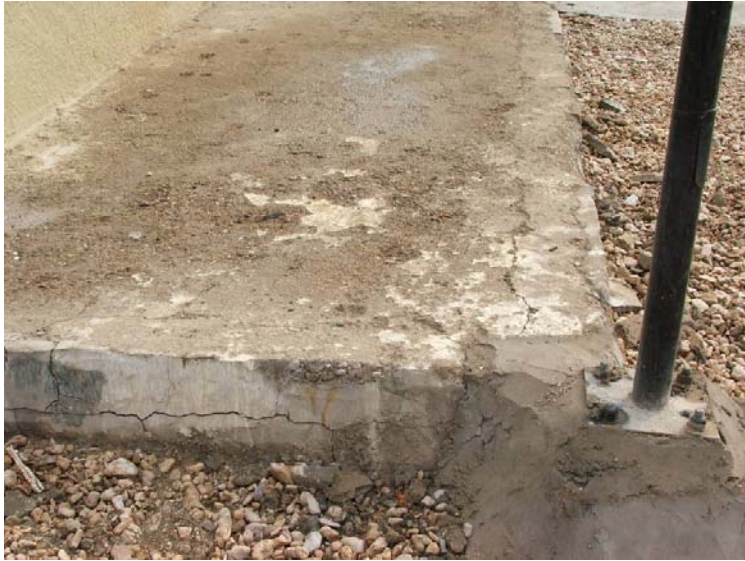
“Concrete shall be free from excessive voids or cracks when poured and be wetted sufficiently as to avoid stress cracking due to excessive moisture loss.”

We did not find any of the sidewalks with a broom finish. Further, we observed a very rough surface texture and cracking in some of the sidewalks (Site Photo 10).

Site Photo 10. Rough Surface Texture and Cracks in Concrete Sidewalk

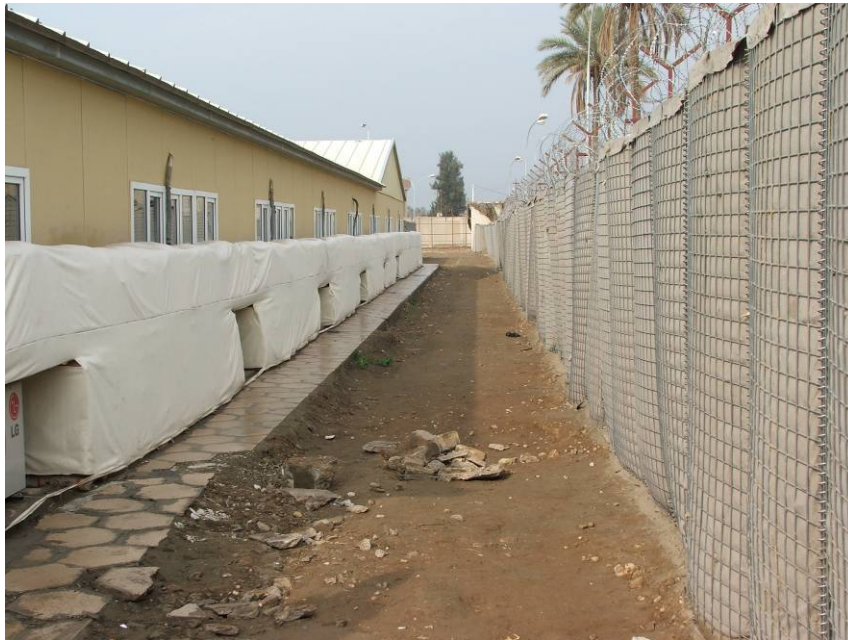
DABV01-04-M-8069: Insufficient security wall strength and mass to withstand an attack. Our assessment showed that perimeter walls adjacent to classrooms or berthing areas are reinforced with Hesco walls on the inside of the perimeter wall. Site Photo 11 shows the Hesco wall adjacent to classrooms along the north perimeter wall. The Hesco walls at the police academy were not constructed by GBG. They were installed under a separate contract awarded and administered by JCC-I/A.

Site Photo 11. Hesco Wall Reinforcing the Outside Concrete Perimeter Wall

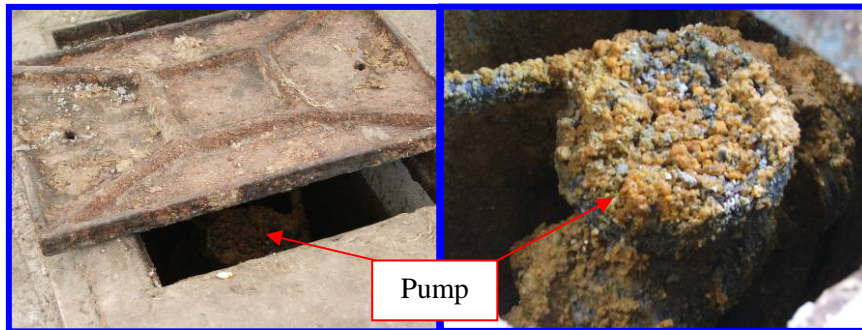
DABV01-04-M-8070: The wastewater facility did function as the contract required. The contractor did not resolve the design, capacity, and operation issues. Although, the system was designed to operate with two pumps, only one pump was installed.

The contract originally called for a wastewater lift station with a grinder pump (and a backup pump) capable of transferring effluent 500 linear feet from the camp to the nearest city sanitary sewer manhole; our assessment showed one pump. The wastewater

is not pumped to a city sanitary sewer manhole but it is pumped to wastewater collection tanks on site where it is stored until collected by vacuum trucks. Site Photo 12 shows the grinder pump basin and a close-up of the pump. The pump is entirely encrusted with deleterious material deposits which indicate no preventive maintenance was performed.

Site Photo 12. Grinder Pump Basin with Close-up of Pump

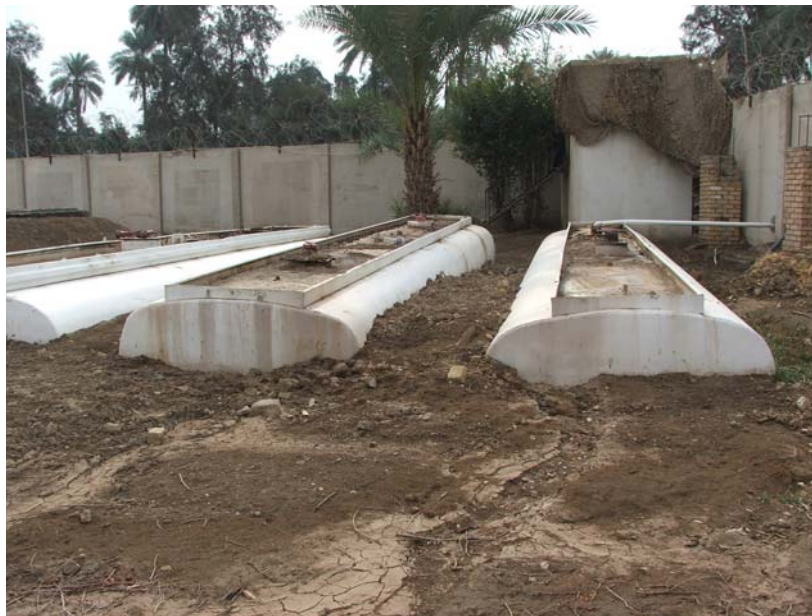
Site Photo 13 shows a series of three wastewater collection tanks. Wastewater is stored in these tanks until pumped out by the vacuum trucks. Since there was no design or as-built drawings showing the layout of the sanitary sewer lines or system flow diagrams, we could not determine specifically if (and how) the three tanks are interconnected below grade, nor could we determine how other connections are made from the latrines or from the dining facility.

Site Photo 13. Wastewater Collection Tanks Partially Buried

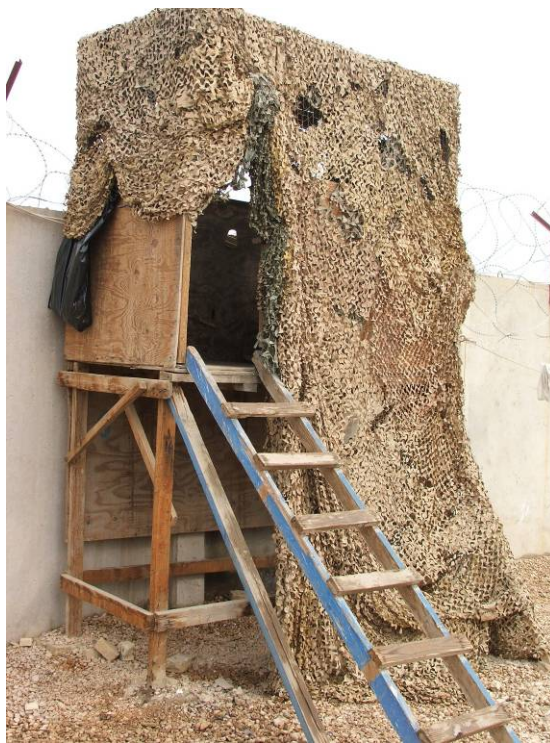
Guard towers exist along the perimeter at the Hilla Police Academy. However, they are wood towers as seen in Site Photo 14 and GBG did not install them.

Site Photo 14. Guard Tower at the Hillah Police Academy

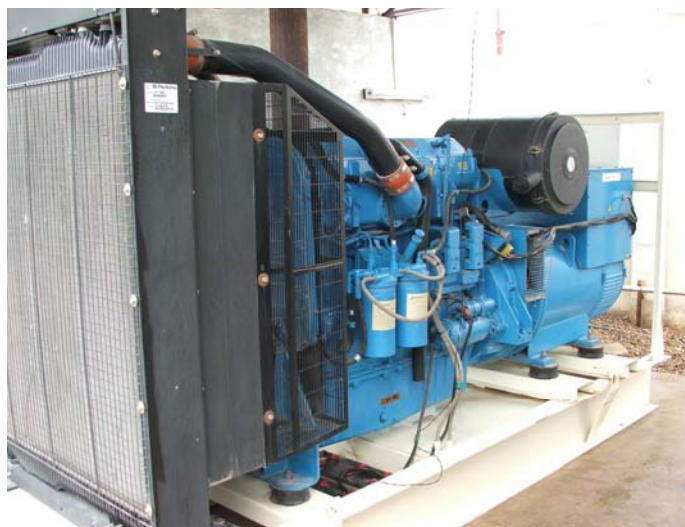
SIGIR Audit Report 05-16, notes that three generators were purchased for the police academy -- two 500-kilowatt generators and a one-megawatt generator. The report mentions that the one-megawatt generator and one of the 500-kilowatt generators had not been delivered. Further, the 500-kilowatt generator that had been delivered was offsite for repairs. We observed two generators during our site visit. While onsite, we ascertained that GBG had not supplied either one. The larger generator, shown in Site Photo 15, is rated at 615 kilowatts according to factory plate information.

Site Photo 15: 615 KW Generator at the Hilla Police Academy

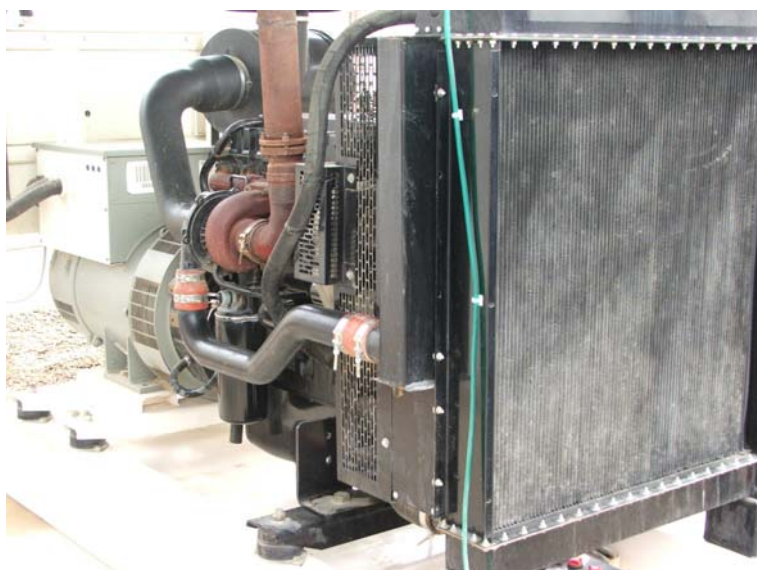
The other generator onsite, shown in Site Photo 16, is rated at 220 kilowatts. While on site, an employee of the current life support contractor, SBIG, started the engines on both generators and let them run for several minutes. However, the generators did not carry any electrical load during the test runs. The police academy currently relies on commercial power as its primary source of electricity, with the generators serving as a backup. At this time, it could not be determined how much of the electrical demand from the police academy could be supported with power supplied solely from the two generators.

Site Photo 16: 220 KW Generator at Hilla Police Academy
